# PHOTOVOLTAICS IN BUILDINGS

## DOMESTIC FIELD TRIAL

### Newbiggin Hall Estate, Newcastle upon Tyne

*This is an example of photovoltaic (PV) installations in a social housing refurbishment in Westerhope. Here the PV installation of arrays was combined with other improvement work including an upgrade of insulation, fire-stopping and an extensive overhaul of the external fabric.*

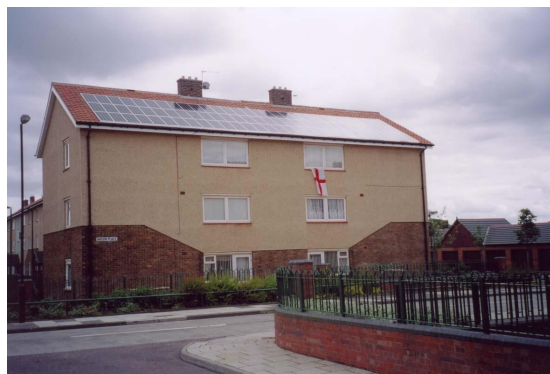
- **38.25 kWp installed capacity**
- **BP 585 Laminates, roof mounted**
- **25 systems on social housing block**
- **Average annual yield – 688 kWh/kWp**
- **Average annual savings 11.3 tonnes CO<sub>2</sub>**
- **Average Performance Ratio – 72%**

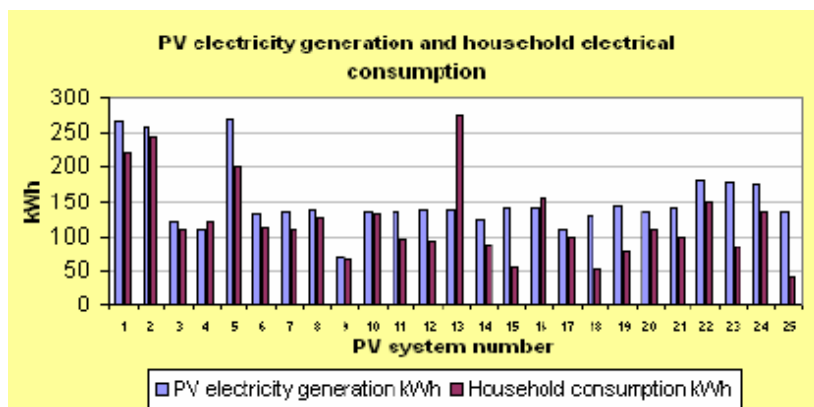
*Overall performance of all the systems has been very good. The graph shows electricity generated by the PV system in June 2005 and household electricity consumption*

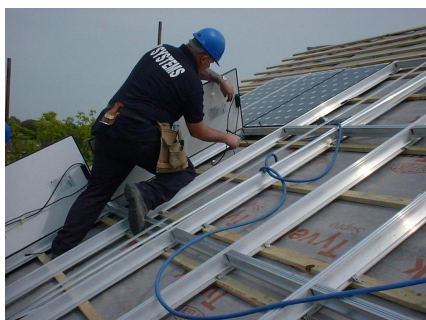
*Series connection of a laminate*

The programme of re-roofing was carried out by NCC City Build, who stripped the tiles and fitted the boarding, felting and battening. PV Systems then followed this with the installation of the RIS aluminium PV frames. These were assembled on site and a hoist was provided by NCC to lift up panels to the roof to conform with health and safety lifting requirements. The frames were secured to the battens using screwed clips clamping the vertical rail section.

Laminates were fitted into each frame as work progressed to ensure that the frames were square to the roofline and adjacent frames. They were sealed using a perimeter rubber gasket and fixed with

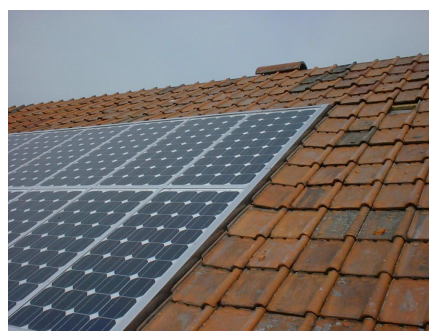
*The completed PV array*

aluminium capping strips riveted into place. Once the arrays were completed and tested NCC City Build completed the roof work, i.e. replacing the tiles, flashings, etc.
