PHOTOVOLTAICS IN BUILDINGS

DOMESTIC FIELD TRIAL

Pinehurst, Liverpool

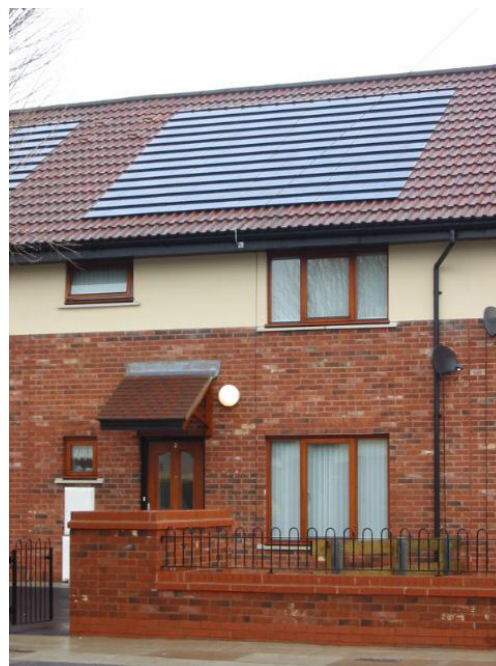
Within the estate's renovation programme, nine of the 55 houses were deemed to be beyond economic repair. Hence the decision was taken to build nine new properties incorporating photovoltaics (PV). The Redland PV700 tile system was chosen because the rest of the estate uses conventional Redland tiles. There are 40 PV tiles (1.4kWp orientated 55° W of S) on five smaller houses and 48 tiles (1.68kWp orientated 24° W of S) on four larger ones. One PV tile displaces four conventional tiles. All roofs are at an angle of 35°. The PV tiles are designed to fit in with the conventional tiles' horizontal lines resulting in flushness with the roof. Also the contrast in colour between the red tiles and blue PV modules was deliberate. The overall result is an uncluttered roof with an eye-catching PV system.

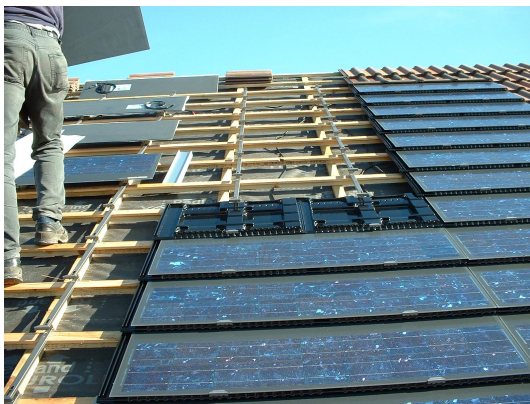
Plastic tray installed with PV module about to be placed on it

Installing the Redland mounting system was generally straightforward. Once the battening was completed the PV tiles were installed in a two stage process. Firstly, the proprietary mounting system was attached to the battens allowing the plastic trays to be fitted. These mesh with the Redland tiles, ensuring weather tightness of the assembly and ensuring back ventilation. Secondly, the modules are connected together electrically and clipped into place. One concern with this system highlighted by some installers was that access to failed panels or to connectors for testing was only possible by removing the panels from the top down, potentially resulting in some onerous maintenance work if the bottom panel needs replacing.

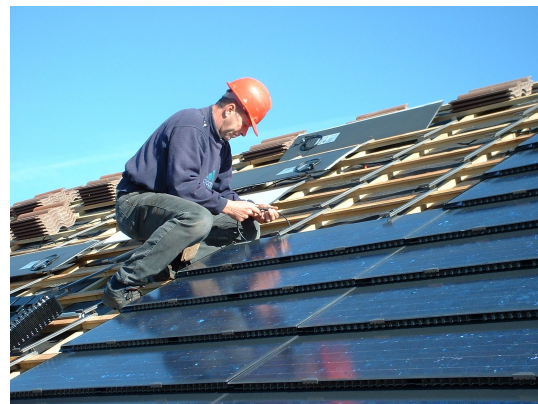
Making the electrical connections using the straight forward Multi-Contact plug system

The roofers made the electrical connections between the modules as they progressed, using Multi-Contact (MC) connections which are touch-safe. The connections were made as straightforward as possible by installing the modules in columns to form a string from bottom to top. The strings comprised ten or twelve modules depending on the site. The PV contractor returned to test the continuity of the strings after the modules were installed and before the scaffolding came down.

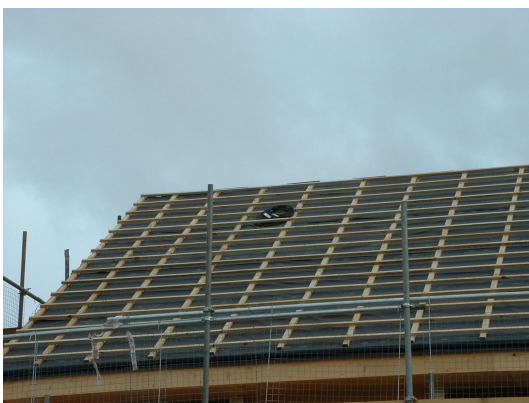
Counter battens (verticals) installed correctly for cooling, beneath battens

There was some minor problems with the PV integration, for example on the first completed roof the roofer placed the felt between the counter battens and battens instead of underneath both, therefore reducing the ventilation air gap. Emphasising the correct sequence of the counter battening here is crucial as this will be unusual practice to roofers. The battens at Pinehurst had to be re-done causing a slight delay, although this did not affect the overall scheduling. Visual integration of the rooflights was also less straight forward than anticipated.

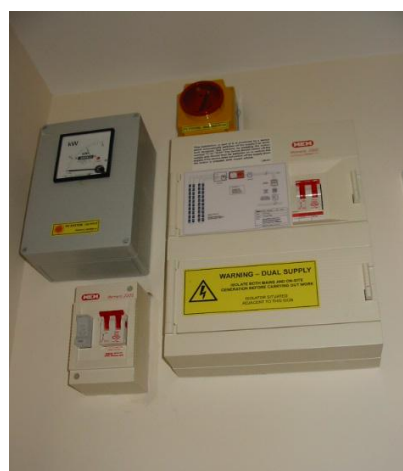
Tenant display meter (top left) mounted next to the consumer unit

There were some initial, although minor, problems with an export meter and one of the tenant's display meters, all of which were promptly rectified. One tenant was questioning her high electricity bills but monitored data confirmed that her electricity use was high and that her power meter was not faulty.
